**ALASKA DEPARTMENT OF ENVIRONMENTAL CONSERVATION**  
**Division of Spill Prevention and Response**  
**Prevention and Emergency Response Program**

**SITUATION REPORT**

**INCIDENT NAME:** AEA Akiachak Tank Farm

**SPILL NUMBER:** 03279936401

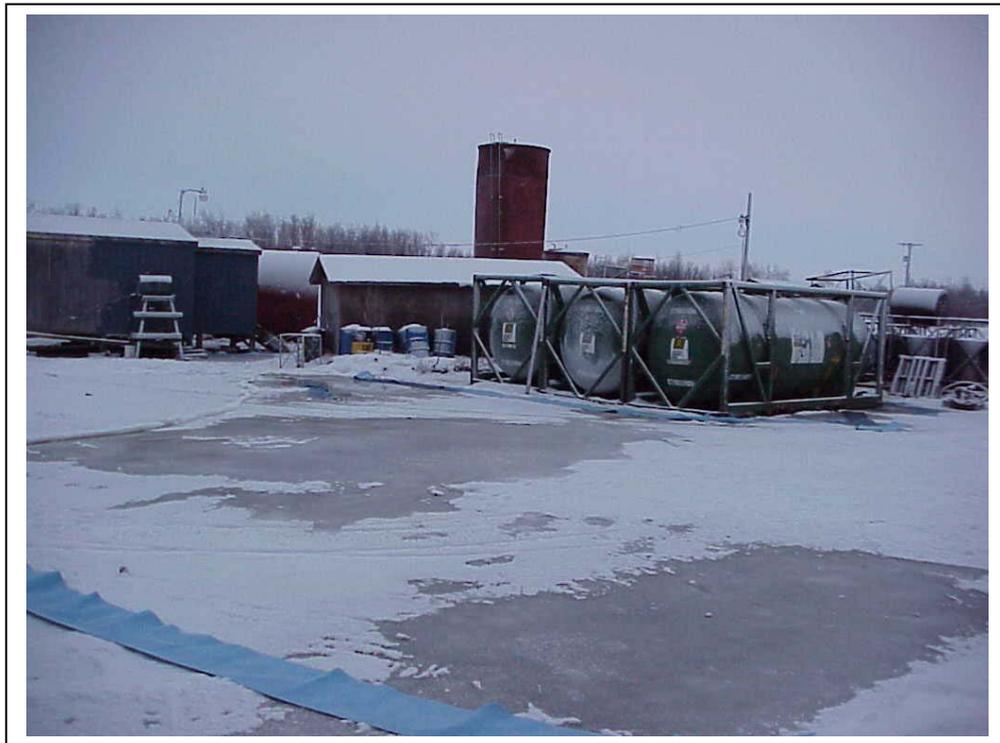
**CAUSE OF SPILL:** Fuel apparently leaked from a 5000-gallon isotank owned by the STG, Inc. a Contractor hired by the AEA. The cause of the spill is under investigation.

**RESPONSE ACTION:** An immediate action by the tank farm operator was to deploy sorbent sweep as depicted in the attached photo. The spill site is frozen which provided additional containment for the spilled fuel.

Looking northeast at the spill site. The green isotank on the far right is the suspected source of the spill.

**SOURCE CONTROL:** The leak has slowed or stopped. The suspected isotank will be removed from the site and placed in secondary containment.

**FUTURE PLANS AND RECOMMENDATIONS:** Once the free product has been collected, contaminated snow, ice, and soil will be removed from the site. STG, Inc. has hired an environmental consulting firm to draft a cleanup workplan for ADEC approval including waste disposal plans, and to provide on-site cleanup guidance.
