SITUATION REPORT

INCIDENT NAME: EAFB Product Recovery Tank Spill **SITREP #:** 2

LOCATION: West Ramp Pumphouse Building 13196, EAFB.

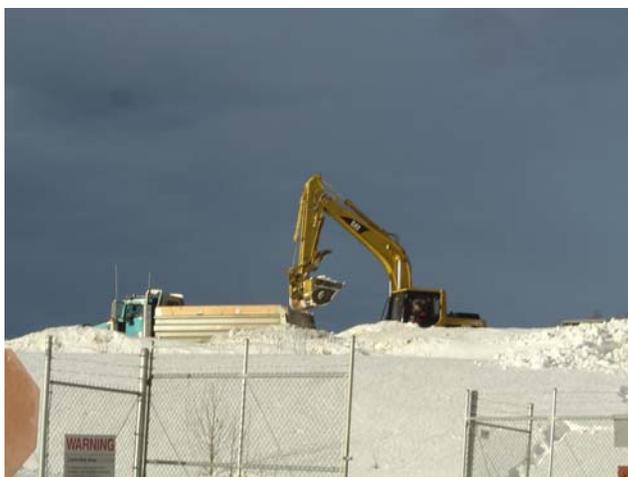
Fuel contaminated snow being loaded into a dump truck for transport to disposal site.

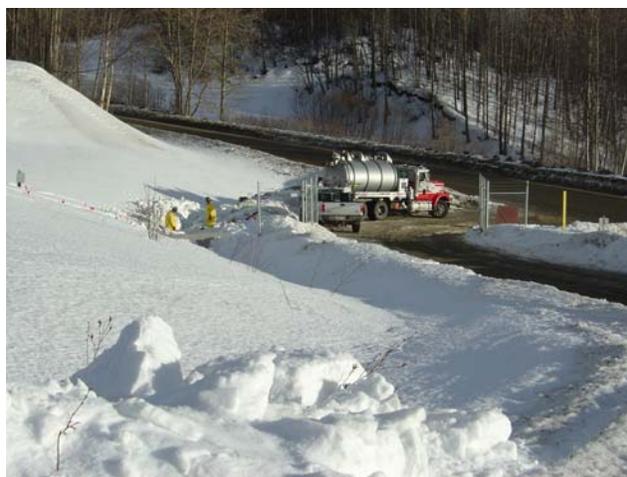
Response worker's using a vacuum truck to recover fuel from a ditch at the lower end of the spill area.
