**SITUATION REPORT**

**INCIDENT NAME:** BPXA L-1 Test-Header Pipeline Leak

**SITREP #:** 1

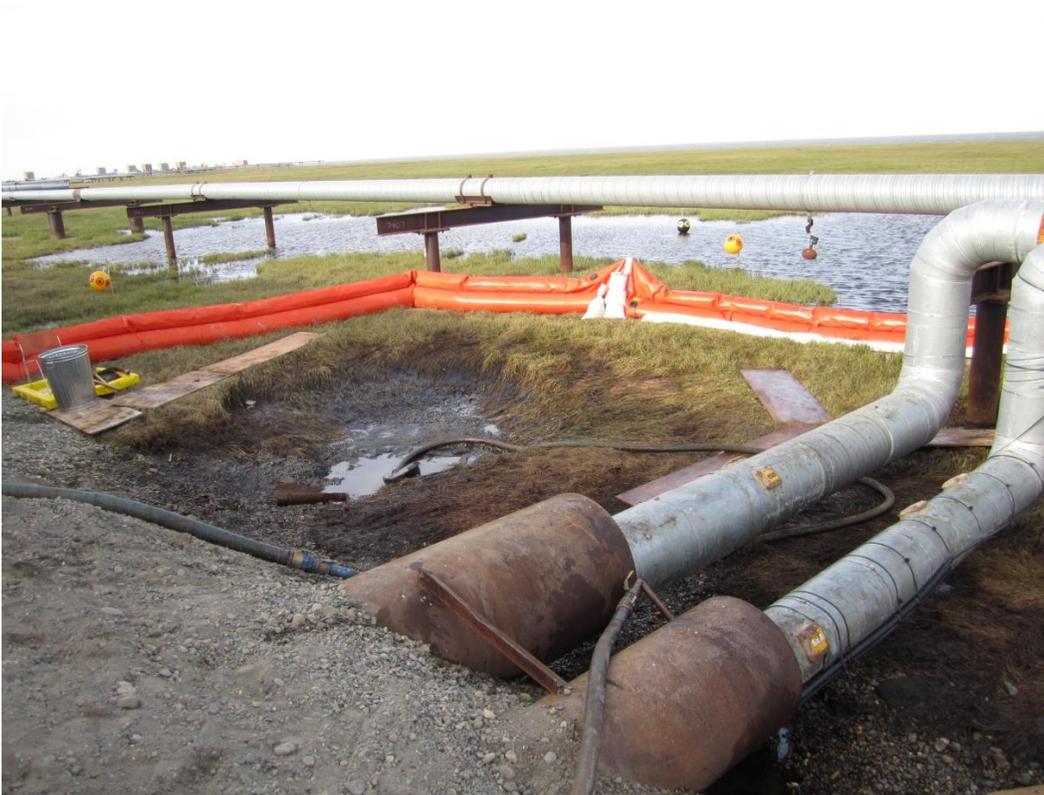
Lisburne Production Center L-1 drill site viewing north at the release point at the pipeline road crossing.

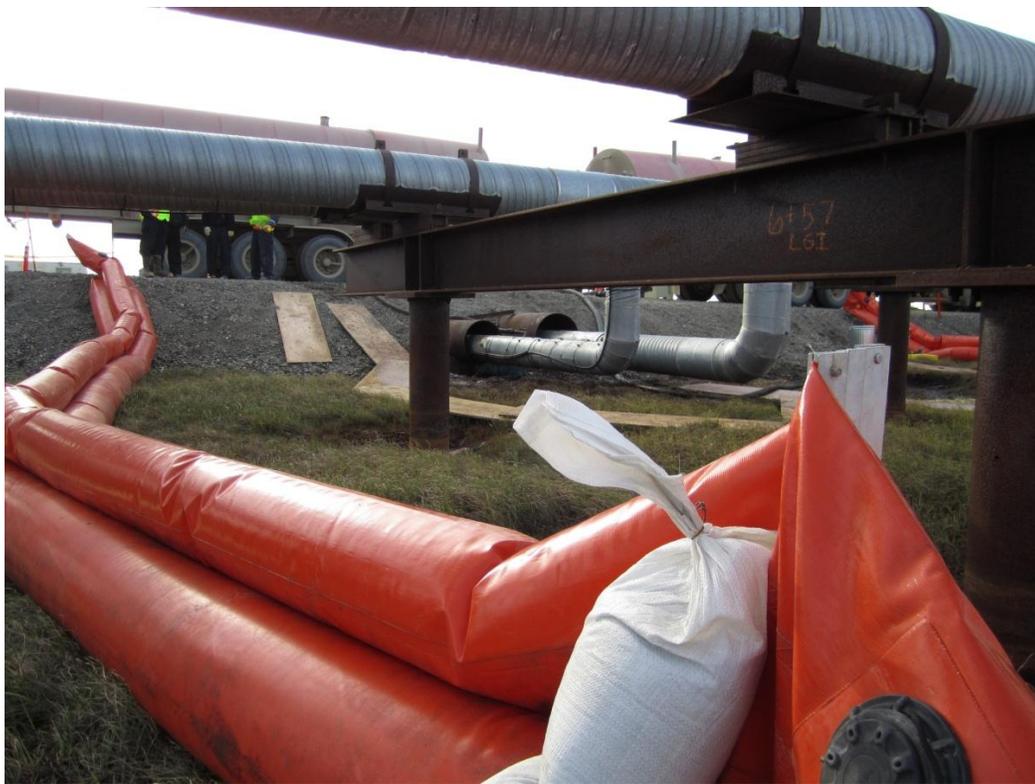
Viewing road crossing at pipeline release.
